**HISTORIC RESOURCES INVENTORY:**  
Buildings & Structures

**SURVEY OF GUILFORD, NEW HAVEN COUNTY, 06437**  
June-December 1981

1. ADDRESS 974 Leete's Island Road  
(map 18, lot 9)
2. NAME  
(historic) George Watrous  
NAME  
(common)
3. USE  
(historic)  
USE  
(present) Private house
4. IF MOVED, WHEN AND FROM WHERE:

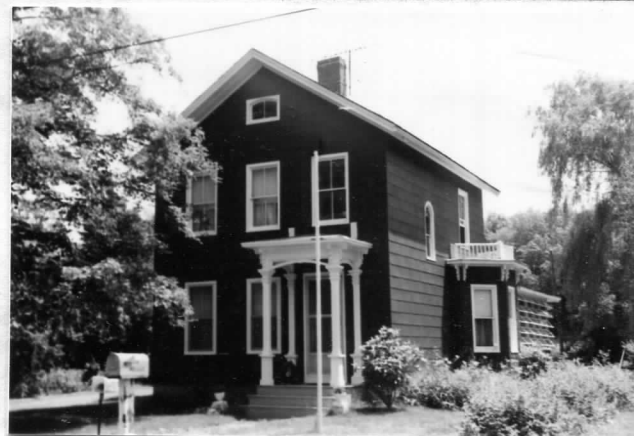
GLFD NEG 6:33

5. ARCHITECT
6. DATE 1875
- BUILDER
- STYLE Vernacular Italianate
7. ALTERATIONS  
Siding; back porch; some window sashes.
8. NOTABLE FEATURES Wide overhanging eaves; arched gable window; arched stairway window with stained glass; bay window with brackets and a balustrade; porch with beveled posts, brackets and braces; large block foundation.

9. ARCHITECTURAL-HISTORICAL  
Several fine Victorian details enliven this house; particularly notable are the front porch with brackets and braces and the bay window with a balustrade on top of its bracketed roof.  
According to the diary of Henry W. Norton, George Watrous, who built this house, raised it in 8° below zero weather on January 19, 1875.
