HISTORIC RESOURCES INVENTORY:
Buildings & Structures

SURVEY OF GUILFORD, NEW HAVEN COUNTY, 06437
June-December 1981

1. ADDRESS 316 Little Meadow Road
(map 86, lot 2)
2. NAME (historic) H.N. Davis
NAME
(common)
3. USE
(historic)
USE
(present) Private house
4. IF MOVED, WHEN AND FROM WHERE:

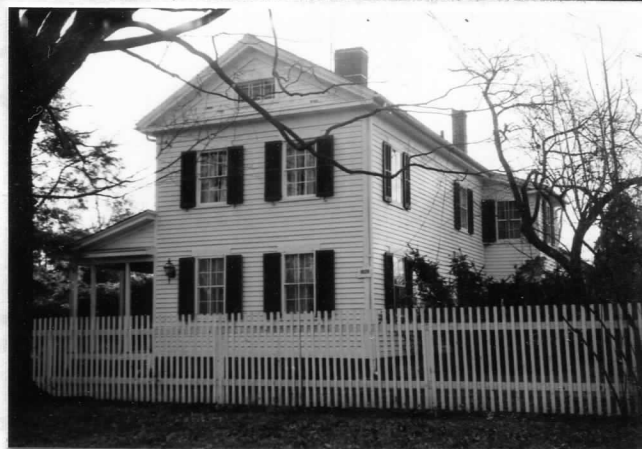
5. ARCHITECT
6. DATE c1854
- BUILDER
STYLE Greek Revival
7. ALTERATIONS
Side porch; rear addition.

8. NOTABLE FEATURES
Boxed pedimented cornice; rectangular gable window with decorative muntins; frieze; 6/6 sash; wide lintels.
9. ARCHITECTURAL-HISTORICAL
The narrow gable end of this Greek Revival house is unusual for Guilford. The entry way, normally found on the gable end, in this example is on the side of the house. With its fine picket fence, it is an important part of the district.
