HISTORIC RESOURCES INVENTORY:
 Buildings & Structures

SURVEY OF GUILFORD, NEW HAVEN COUNTY, 06437
 June-December 1981

1. ADDRESS 992 Little Meadow Road
(map 91, lot 36)
2. NAME
(historic) S. Davis
NAME
(common)
3. USE
(historic)
USE Private house
(present)
4. IF MOVED, WHEN AND FROM WHERE:

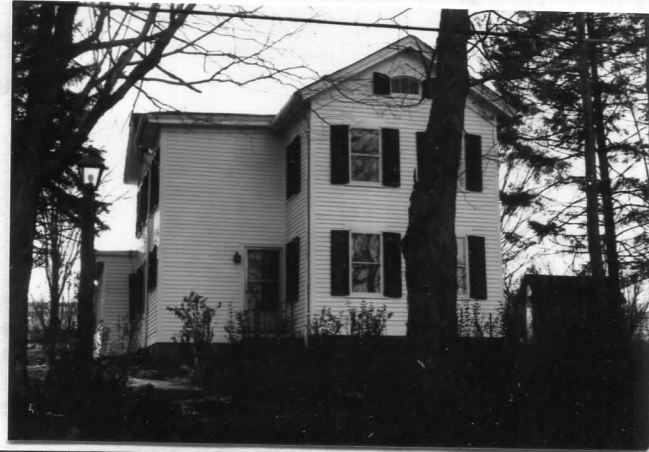
5. ARCHITECT
6. DATE c1850 BUILDER STYLE Vernacular
7. ALTERATIONS Window sash; addition to the side wing (closed in area probably was a porch originally).
8. NOTABLE FEATURES Boxed cornice; wide frieze; slightly arched window in the gable.
9. ARCHITECTURAL-HISTORICAL The narrow width of its two perpendicular wings give this house a very tall appearance. With its barns and treed lot, it plays a good role in supporting the rural character of its district.
