HISTORIC RESOURCES INVENTORY:
Buildings & Structures

SURVEY OF GUILFORD, NEW HAVEN COUNTY, 06437
June-December 1981

1. ADDRESS 1169 Long Hill Road
(map 85, lot 12-5)
2. NAME
(historic)
NAME
(common)
3. USE
(historic)
USE
(present) Private house
4. IF MOVED, WHEN AND FROM WHERE:

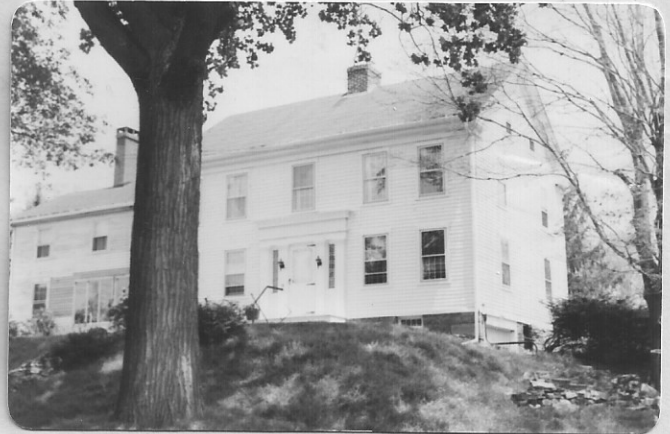
5. ARCHITECT 1836-50
6. DATE 1836-50
- BUILDER STYLE Federal/Greek Revival
7. ALTERATIONS Large addition (with a boxed cornice with returns, and a rectangular gable window c1840; large windows c1880; chimney; front steps and a railing; garage.

8. NOTABLE FEATURES Boxed cornice with returns; frieze; a row of dentils below the moulding under the eaves and raking; 12/12 sash; 2/6 windows in the gable; Greek Revival doorway with a double set of pilasters with sidelights between and an entablature with a row of dentils; dressed stone foundation.

9. ARCHITECTURAL-HISTORICAL
This house, set on a ridge above Long Hill Road, has the basic form of the Colonial and Federal houses of this period. Its doorway, an exceptionally wide Greek Revival example with paired pilasters and a sidelight on either side of the door, is a remarkable feature of the house. A row of dentils ornamenting the entablature echoes one in the eaves and raking.
This house is on the east side of Long Hill Road and appears on the 1852 Irvine Map across the road from the James S. Loper property sited west of the road. Subsequent maps dated 1856 (Smith's county map) and 1868 (Beers' Atlas) show the Loper property on the east side of Long Hill Road - a fact which has led to the suggestion that this is the James S. Loper house. Given its location, it appears unlikely that it was moved.
