HISTORIC RESOURCES INVENTORY:
Buildings & Structures

SURVEY OF GUILFORD, NEW HAVEN COUNTY, 06437
June-December 1981

1. ADDRESS 2219 Long Hill Road
(map 101, lot 2)
2. NAME David Stone
(historic)
NAME
(common)
3. USE
(historic)
USE
(present) Private house
4. IF MOVED, WHEN AND FROM WHERE:

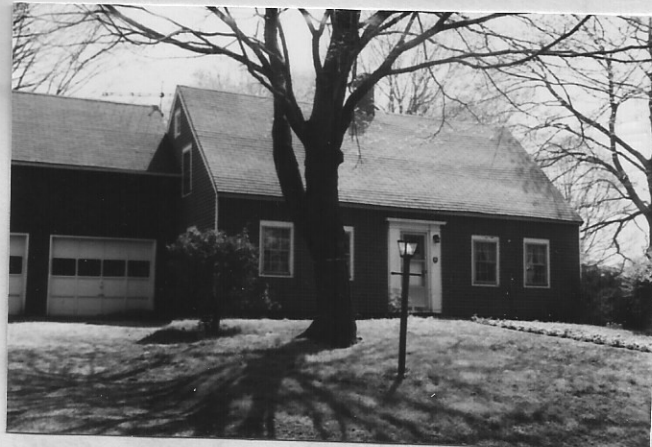
5. ARCHITECT
6. DATE 1793 BUILDER
STYLE Federal
7. ALTERATIONS
Siding; large garage addition; rear addition; chimney; 6/6 sash.

8. NOTABLE FEATURES
Four pane gable window; doorway with pilasters, and a protruding cornice.
9. ARCHITECTURAL-HISTORICAL
The pilasters and cornice that surround the doorway of this house are an expression of the Federal style. The house is a good example of the story-and-a-half in its 18th century form.
