HISTORIC RESOURCES INVENTORY:
Buildings & Structures

SURVEY OF GUILFORD, NEW HAVEN COUNTY, 06437
June-December 1981

1. ADDRESS 234 Long Hill Road
(map 52, lot 5)
2. NAME
(historic) Philemon Hall
NAME
(common)
3. USE
(historic)
USE
(present) Private house
4. IF MOVED, WHEN AND FROM WHERE:

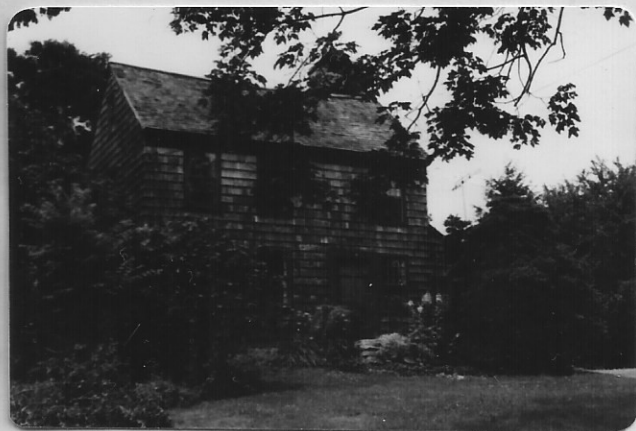
GLFD NEG 4:3

5. ARCHITECT
6. DATE 1756 BUILDER STYLE Colonial - Half House
7. ALTERATIONS Rear-side addition (1952); rear dormer and overhang (1942); shingle siding.
8. NOTABLE FEATURES Three bay facade (with a door and a window sharing a common jamb); moulded eaves with a moulding below the eaves; narrow frieze; 12/12 sash in the third floor and in the second floor lean-to portion; paneled door; stone foundation and chimney.

A "half-house" - a typical "saltbox" except that the portion at one side of the chimney was omitted, presumably to be added later. The house faces East, a lean-to at the north of the chimney may have preceeded the main house. The interior was extensively remodeled in the early Federal period. The exterior, originally clapboards, is now shingled.

The front or east wall slopes outward at an angle of about 3° presumably to shed rain better. This is an original feature of the house, not an aging effect. The ceiling heights are: ground floor 9'-5"; second floor 9'-0".
