HISTORIC RESOURCES INVENTORY:

SURVEY OF GUILFORD, NEW HAVEN COUNTY, 06437

2548 Long Hill Road (map 100, lot 24)

William Dudley

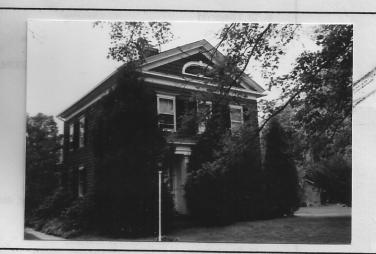
Shingle siding; rear shed roof addition.

Boxed cornice (pedimented); freize; elliptical fanlight with a keystone trim; 6/6 sash; crown mouldings over the windows; recessed doorway with pilasters; entablature; sidelights and a decorative door frame: stone block foundation.
9. ARCHITECTURAL-HISTORICAL

Guilford has few houses with fanlighted gable ends facing the street. Long Hill Road has two closely related houses, this one and no. 2734. In addition to the distinctive fanlight in its pedimented gable, this house has a doorway in which pilasters and an entablature form a reces for a door with a decorative frame and sidelights. It faces the Stephen Fowler house across the street.
