HISTORIC RESOURCES INVENTORY:
 Buildings & Structures

SURVEY OF GUILFORD, NEW HAVEN COUNTY, 06437
 June-December 1981

1. ADDRESS 2733 Long Hill Road
(map 104, lot 12)
2. NAME
(historic) Josephine Norton
NAME
(common)
3. USE
(historic)
USE
(present) Private house
4. IF MOVED, WHEN AND FROM WHERE:

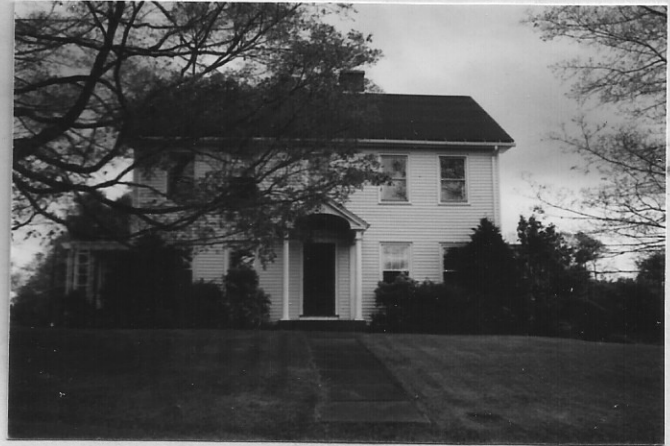
5. ARCHITECT
6. DATE c1920 BUILDER STYLE Colonial Revival
7. ALTERATIONS
Siding.
8. NOTABLE FEATURES
Cornice with returns; 6/1 window sash; front porch with slender columns and a pediment door hood (with an arched interior); solarium; stone foundation.

9. ARCHITECTURAL-HISTORICAL
A few aspects of this simple and stately house refer back to its Colonial antecedents; placement of windows, a doorhood with pediment, and a cornice with returns all get an early 20th century treatment here. The scale and proportion of this house make it a pleasant part of its semi-rural neighborhood.
