HISTORIC RESOURCES INVENTORY:
 Buildings & Structures

SURVEY OF GUILFORD, NEW HAVEN COUNTY, 06437
 June-December 1981

1. ADDRESS 2734 Long Hill Road
 (map 104, lot 17)
2. NAME
 (historic) Field
 NAME
 (common)
3. USE
 (historic)
 USE
 (present) Private house
4. IF MOVED, WHEN AND FROM WHERE:

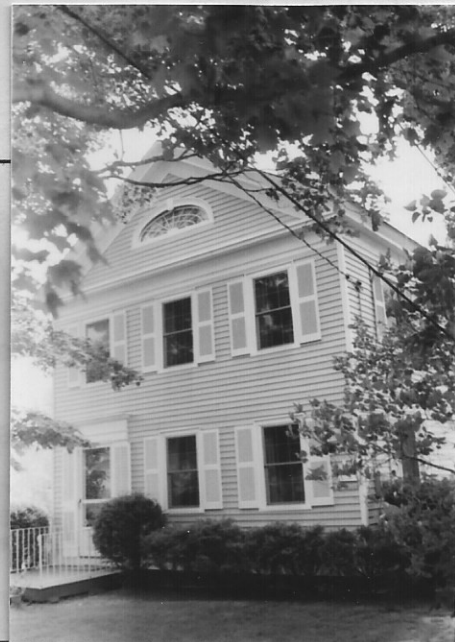
5. ARCHITECT
6. DATE c1825
7. ALTERATIONS
 Siding.
8. NOTABLE FEATURES
 Boxed cornice (pedimented); frieze; elliptical fanlight in the gable with radiating muntins and a keystone trim; 6/6 sash; doorway with pilasters and an entablature; large brick chimney; stone block foundation.
9. ARCHITECTURAL-HISTORICAL

This house has a pedimented gable with an elliptical fanlight on its front similar to that on the house at 2548 Long Hill Road. Its entrance, however, is a simpler construction of pilasters and an entablature.
