**HISTORIC RESOURCES INVENTORY:**  
Buildings & Structures

**SURVEY OF GUILFORD, NEW HAVEN COUNTY, 06437**  
June-December 1981

1. ADDRESS 144 Moose Hill Road  
(map 66, lot 35)
2. NAME  
(historic) Samuel W. Leete  
NAME  
(common)
3. USE  
(historic)  
USE  
(present) Private house
4. IF MOVED, WHEN AND FROM WHERE:

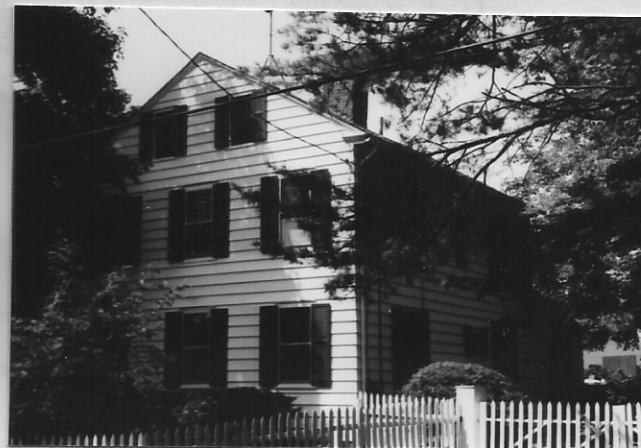
5. ARCHITECT
6. DATE 1834
- BUILDER  
STYLE Federal
7. ALTERATIONS  
Siding; side addition; the original doorway on the side;  
screened porch.

8. NOTABLE FEATURES  
Overhanging eaves with a moulding below; 12/12 sash; two 6/6 sash  
gable windows; moulding around the door frame; very stylized  
entablature over the door.
9. ARCHITECTURAL-HISTORICAL The modest form and pleasant proportions of  
this house are enhanced by the surrounding  
picket fence. It is a good example of the simpler versions of  
the Federal style.  
Samuel Willis Leete, born 17 April 1812, son of Edmund,  
was the original owner of this house. Leete died in 1877, leaving  
one child, Judson Wyllis. Leete was one of the original Trustees  
of the Methodist Episcopal Church of Guilford.
