HISTORIC RESOURCES INVENTORY:
Buildings & Structures

SURVEY OF GUILFORD, NEW HAVEN COUNTY, 06437
June-December 1981

1. ADDRESS 172 Moose Hill Road
(map 66, lot 36)
2. NAME
(historic) John Morse
NAME
(common)
3. USE
(historic)
USE
(present) Private house
4. IF MOVED, WHEN AND FROM WHERE:

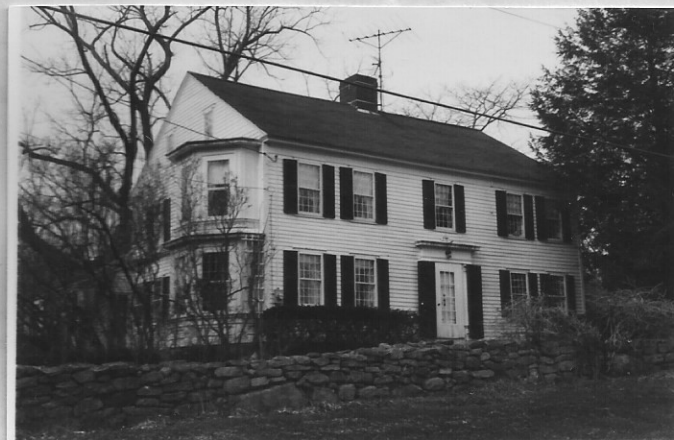
5. ARCHITECT
6. DATE c1758 BUILDER
STYLE Colonial
7. ALTERATIONS
Two story side bay; brick chimney; Greek Revival doorway with pilasters and entablature.
8. NOTABLE FEATURES
Boxed cornice, with a moulding below; frieze; 12/12 sash; two 6/6 sash in the gable.

9. ARCHITECTURAL-HISTORICAL
This house has a well-balanced nine-window facade, enhanced by its small-paned windows, important features. Later changes, such as the Greek Revival doorway and the 19th century two-story bay are discreet additions.
