HISTORIC RESOURCES INVENTORY:
Buildings & Structures

SURVEY OF GUILFORD, NEW HAVEN COUNTY, 06437
June-December 1981

1. ADDRESS 1820 Moose Hill Road
(map 77, lot 5)
2. NAME
(historic) Samuel Kelsey
NAME
(common)
3. USE
(historic)
USE
(present) Private house
4. IF MOVED, WHEN AND FROM WHERE:

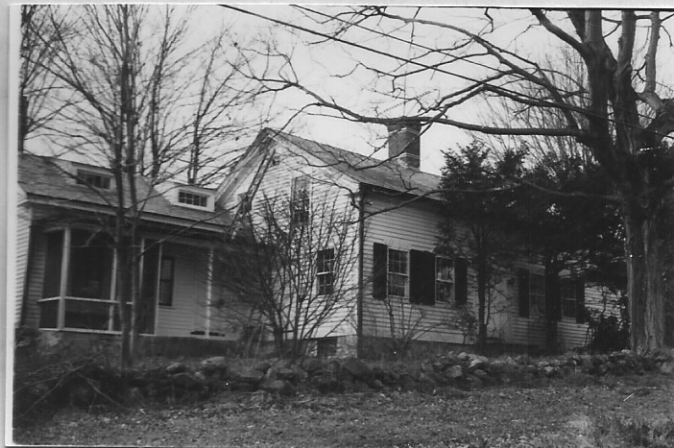
5. ARCHITECT
6. DATE c1815
- BUILDER
STYLE Federal
7. ALTERATIONS
Side additions; rear addition; rear roof line altered; chimney rebuilt.
8. NOTABLE FEATURES
Boxed cornice with returns (on the sides); 6/6 sash; doorway with pilasters, and an entablature; rectangular windows in the gable.

9. ARCHITECTURAL-HISTORICAL
The broad space above the doors and windows of the facade give evidence of the upper story of this story-and-a-half house. The space also sets off the row of shuttered windows and the entablatured and pilastered doorway. Additions have not impaired the scale of this house, a fine example of its type in a rural setting.
The history of its original owner, Kelsey, remains obscure.
