HISTORIC RESOURCES INVENTORY:
 Buildings & Structures

SURVEY OF GUILFORD, NEW HAVEN COUNTY, 06437
 June-December 1981

1. **ADDRESS** 283 Moose Hill Road
 (map 66, lot 56)
2. **NAME**
 (historic) Ambrose Leete II
 NAME
 (common)
3. **USE**
 (historic)
 USE
 (present) Private house
4. **IF MOVED, WHEN AND FROM WHERE:**

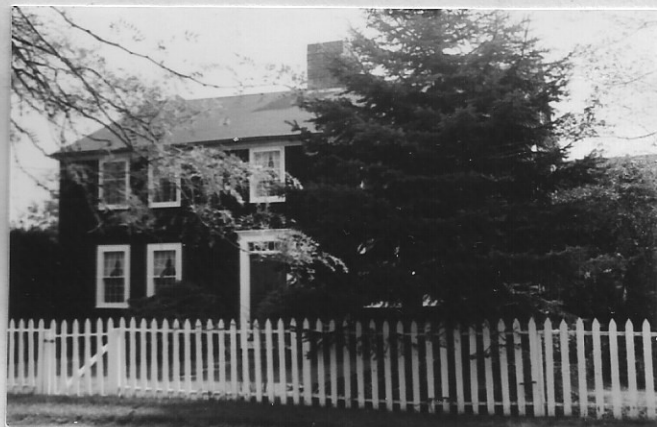
GLFD NEG 6:2

5. **ARCHITECT**
6. **DATE** 1803-4 **BUILDER**
 STYLE Colonial
7. **ALTERATIONS**
 Side wing; rear roof line altered; shed addition.

8. **NOTABLE FEATURES**
 12/12 sash (first floor); 8/12 sash (second floor); 6/6 sash in the gable; door frame flairs at the top; six pane transom with a crown moulding above; brick chimney; stone foundation.

9. **ARCHITECTURAL-HISTORICAL**
 A doorway with a transom and crown molding, and windows with small panes are important features of this house. It is good evidence of the survival of the Colonial style into the beginning of the 19th century.
 Ambrose Leete (II), son of Deacon Ambrose, was the original owner of this property.
