**HISTORIC RESOURCES INVENTORY:**  
Buildings & Structures

**SURVEY OF GUILFORD, NEW HAVEN COUNTY, 06437**  
June-December 1981

1. ADDRESS 48 Moose Hill Road  
(map 19, lot 3)
2. NAME  
(historic) Leete's Island School  
NAME  
(common)
3. USE  
(historic) School  
USE  
(present) Private house
4. IF MOVED, WHEN AND FROM WHERE:

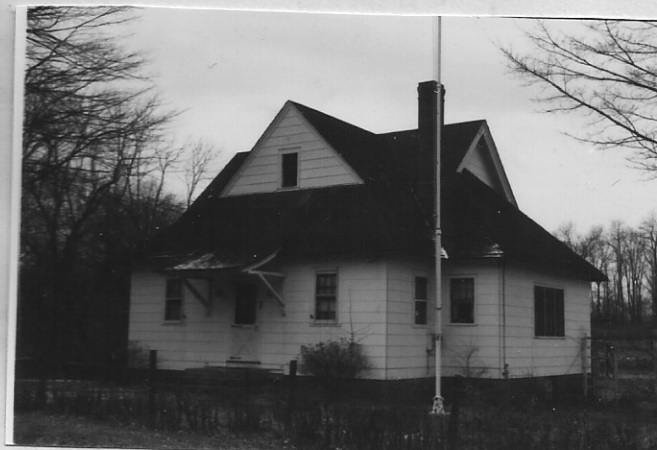
5. ARCHITECT
6. DATE 1895
- BUILDER  
STYLE Shingle/stick
7. ALTERATIONS  
Siding now covers up stick style detailing, door hood has been reduced in size, and a single door replaces two doors.

8. NOTABLE FEATURES  
Overhanging eaves and rafters; brackets at the corners of the gable; 6/2 sash; flared eaves on the door hood (supported by braces); large stone block foundation.

9. ARCHITECTURAL-HISTORICAL Two-room  
This was the "large" Leete's Island School house built in 1895 to replace a small one-room school nearby. It is an example of a late 19th century school building.  
Now a private house, the roof shapes are its principal feature. The roofs of its cross gable form extend on all sides and out from the gable ends thus enclosing more space on this first floor.  
Sold in 1933 at auction the school was converted into a private house in 1935.
