**HISTORIC RESOURCES INVENTORY:**  
Buildings & Structures

**SURVEY OF GUILFORD, NEW HAVEN COUNTY, 06437**  
June-December 1981

1. ADDRESS Narrows Island  
(map 6, lot 6)
2. NAME Peter Beattie  
(historic)  
NAME  
(common)
3. USE  
(historic)  
USE  
(present) Private house
4. IF MOVED, WHEN AND FROM WHERE:

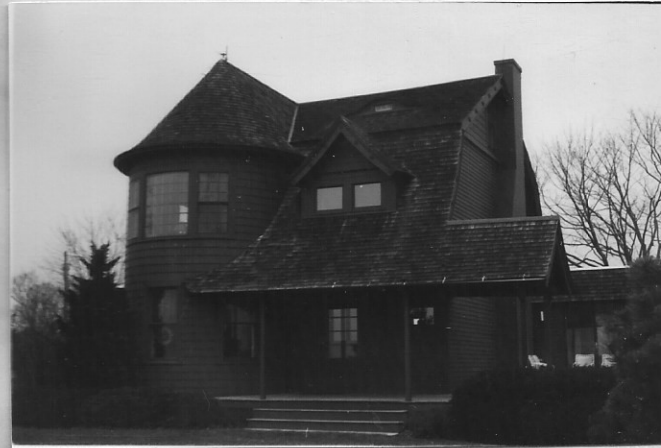
Negative 22:1 A

5. ARCHITECT
6. DATE 1899
- BUILDER  
STYLE Shingle
7. ALTERATIONS  
Rear addition.

8. NOTABLE FEATURES  
Decorative bargeboards; turret with flaired eaves and beveled glass in the windows; eyebrow window; small square post porch.
9. ARCHITECTURAL-HISTORICAL A variety of roof shapes encompass this small two-story house; conical roof over the squat tower, gambrel over the main portion of the house, and the broad sweep of the flaring porch roof becomes a gable roof where it extends beyond the house. An eyebrow window appears in the upper part of the gambrel roof and a flaring gable roof dormer window is below it. A large Palladian-like window is placed in the second floor of the tower. The bargeboards are decorated with a circular motif and wooden shingles cover the roof and tower. The house sits alone on a small island connected to the mainland by a substantial granite causeway. The house was located near the quarry.

15. **CONDITION: Exterior**

☒ Excellent
