HISTORIC RESOURCES INVENTORY:
Buildings & Structures

SURVEY OF GUILFORD, NEW HAVEN COUNTY, 06437
June-December 1981

1. ADDRESS 120 North Fair Street
(map 46, lot 75)
2. NAME
(historic) Guilford Institute
NAME
(common) Shore Line Times Building
3. USE
(historic) School
USE
(present) Newspaper office and
printing plant
4. IF MOVED, WHEN AND FROM WHERE:

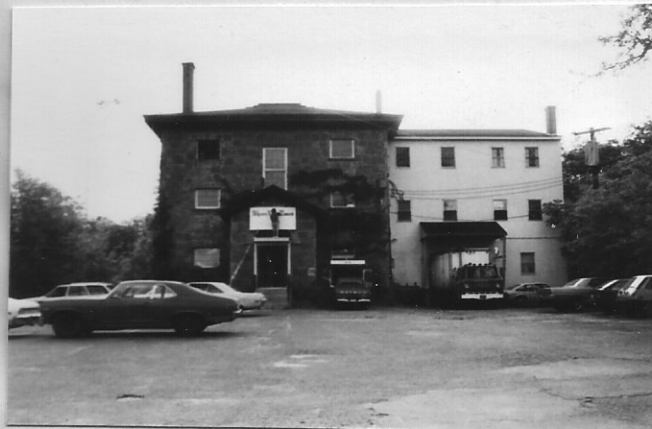
5. ARCHITECT Sidney Mason Stone
6. DATE 1854
- BUILDER
STYLE Italian Villa
7. ALTERATIONS Alterations are so extensive as to have deprived the building of most of its character: fenestration and entry changed, monitor removed, large additions north and west. Also important is the loss of the setting: ground cut away for a gas station to the south, blacktop to the east.
8. NOTABLE FEATURES
The scale of the building remains impressive. This is one of Guilford's few masonry buildings and the only known work in town by Sidney Mason Stone.
