HISTORIC RESOURCES INVENTORY:
 Buildings & Structures

SURVEY OF GUILFORD, NEW HAVEN COUNTY, 06437
 June-December 1981

1. ADDRESS 143 North Fair Street
(map 46, lot 144)
2. NAME
(historic) Solomon Stone
NAME
(common)
3. USE
(historic)
USE
(present) Private house

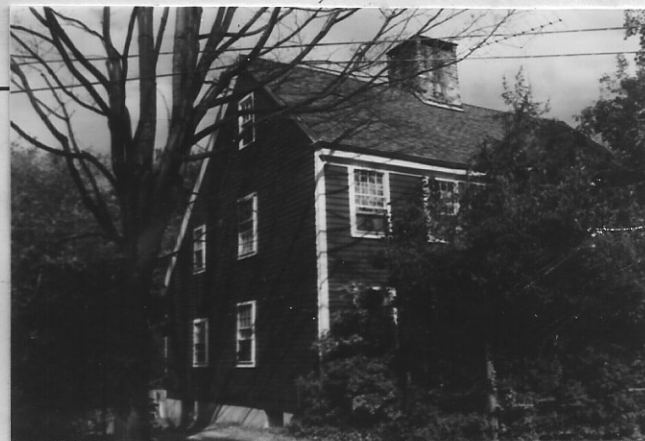
8. NOTABLE FEATURES
 Clapboards' width graduated on facade; 8/12 sash except for the 6/6 sash in leanto; plain door and window frames; stone chimney (rebuilt).

9. ARCHITECTURAL-HISTORICAL Graduated clapboards are an interesting feature of this Colonial house. As in similar houses, this feature appears only on the facade, evidence that its purpose was decoration, not added weather protection. The one-room plan with integral lean-to is typical of the middle 18th century period.
 The house was built for Solomon Stone, whose heirs kept it until the 1920s. Originally at a site between Church and North Fair Streets, bounded on the south by York Street, this house was moved about 100 feet, by the State Highway Department when the Post Road was widened about 1927. In December 1952 the house was moved approximately 1,200 feet and as the crow flies about 300 feet, to its present position at an angle on the east side of North Street.
