HISTORIC RESOURCES INVENTORY:
Buildings & Structures

SURVEY OF GUILFORD, NEW HAVEN COUNTY, 06437
June-December 1981

1. ADDRESS 34 North Madison Road
(map 92, lot 4)
2. NAME
(historic) Edwin C. Davis
NAME
(common)
3. USE
(historic)
USE
(present) Private house, apartment
4. IF MOVED, WHEN AND FROM WHERE:

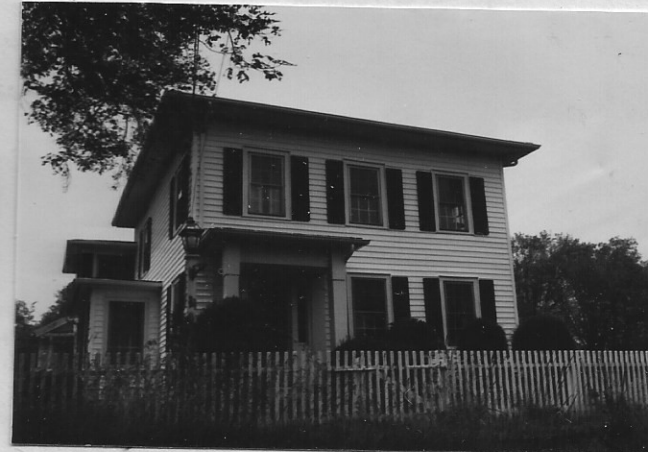
5. ARCHITECT
6. DATE c1849
7. ALTERATIONS
Siding; rear addition.
8. NOTABLE FEATURES
Wide overhanging eaves; 6/6 sash; doorway with sidelights; square post; flat roof front porch.

BUILDER
STYLE Italian Villa

9. ARCHITECTURAL-HISTORICAL
Wide flat eaves are the dominant feature of this house, capping the house itself as well as the entrance portico. Although much detail has been lost to modern siding, the house still retains the stately form of the Italian Villa style. A long picket fence complements the house.
