HISTORIC RESOURCES INVENTORY:
Buildings & Structures

SURVEY OF GUILFORD, NEW HAVEN COUNTY, 06437
June-December 1981

1. ADDRESS 1 North Street
(map 46, lot 111)
2. NAME
(historic) Capt. Samuel Lee
NAME
(common)
3. USE
(historic)
USE Private house
(present)
4. IF MOVED, WHEN AND FROM WHERE:

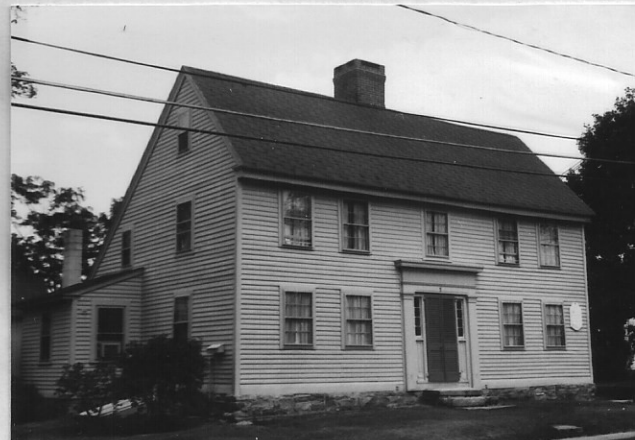
5. ARCHITECT
6. DATE c1750 or c1763
- BUILDER
STYLE Colonial
7. ALTERATIONS
Addition on west side; shingles on east wall; 6/6 sash; chimney rebuilt. The Greek Revival doorway is perhaps c1840s.

8. NOTABLE FEATURES
Boxed cornice with a molding below; one 8/12 window in the gable and one 6/6 which appears old; stone foundation. Inside much old work remains. Well maintained, this is one of Guilford's more striking Colonial houses.
