HISTORIC RESOURCES INVENTORY:
Buildings & Structures

SURVEY OF GUILFORD, NEW HAVEN COUNTY, 06437
June-December 1981

1. ADDRESS 29 North Street
(map 46, lot 108)
2. NAME
(historic) N. S. Norton
NAME
(common)
3. USE
(historic)
USE Private house
(present)
4. IF MOVED, WHEN AND FROM WHERE:

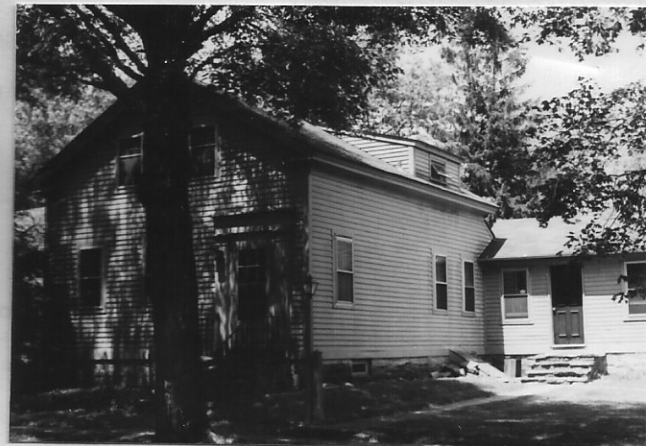
5. ARCHITECT
6. DATE c1855
7. ALTERATIONS
Shed roof dormer; east side wing.

BUILDER
STYLE Greek Revival

8. NOTABLE FEATURES
Boxed cornice with returns; frieze; 6/6 sash; doorway with pilasters and an entablature; stone foundation.

A doorway with pilasters and an entablature at the head of a small flight of steps is a feature of this simple one-and-a-half story house. This is a good example of the town's smaller Greek Revival houses.
