HISTORIC RESOURCES INVENTORY - BUILDING AND STRUCTURES

Building Name (Common) 251 Nortontown Road
 Building Name (Historic) Dickinson Murray House
 Street Address or Location 251 Nortontown Road
 Town/City Guilford Village _____ County New Haven
 Owner(s) Ian M. Quinn Public Private

Style of building Georgian Date of Construction 1831 (Helander)

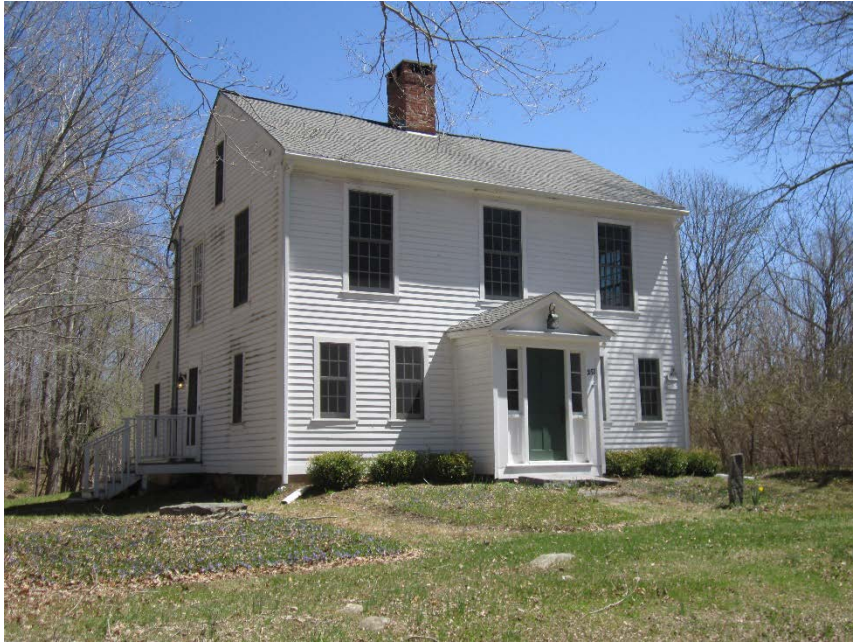
Built in 1831, this Georgian style house sits atop a stone brick foundation and is sheathed in white vinyl siding. The side gable roof is covered in architectural shingles with a slightly off center chimney on the ridgeline. Three large twelve over twelve hung sash windows are located on the second story level. Four six over six hung sash windows are located on the first floor, two on each side of an enclosed, gable roof porch entry with a pediment. (See Continuation Sheet)

Photographer Jordan Sorensen Date 04/26/2015
View Southwest, camera facing northeast Negative on File _____
Name Jordan Sorensen Date 10/27/2015
Organization Guilford Preservation Alliance
Address PO Box 199 Guilford, CT 06437

The green paneled door is flanked with three pane sidelights on either side. A one step stoop leads up to the front door.
