HISTORIC RESOURCES INVENTORY:
Buildings & Structures

SURVEY OF GUILFORD, NEW HAVEN COUNTY, 06437
June-December 1981

1. ADDRESS 40 Old Quarry Road
 (map 12, lot 12)
2. NAME
 (historic)
 NAME
 (common)
3. USE
 (historic)
 USE
 (present) Private house
4. IF MOVED, WHEN AND FROM WHERE:

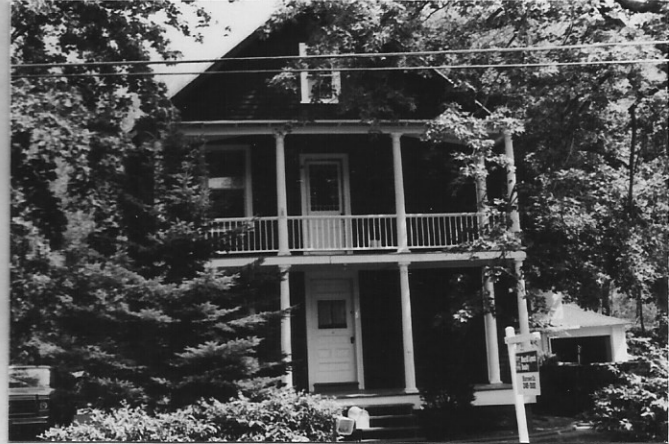
5. ARCHITECT
6. DATE
7. ALTERATIONS
 Outside chimney.
8. NOTABLE FEATURES
 Overhanging eaves; slender bargeboards; two-story porch with round columns and brackets along the eaves; original doors; stone and brick foundation.

9. ARCHITECTURAL-HISTORICAL
 Double decker porches are very unusual on houses in this area. This one offers easy access to the out of doors from the second floor and is an attractive feature of this house, which makes an interesting contribution to its neighborhood.
