HISTORIC RESOURCES INVENTORY:
 Buildings & Structures

SURVEY OF GUILFORD, NEW HAVEN COUNTY, 06437
 June-December 1981

1. ADDRESS 248 (Old) Whitfield Street
(map 33, lot 14)
2. NAME
(historic) Rev. Henry Whitfield
NAME
(common)
3. USE
(historic) Private house
USE
(present) State Historic Museum
4. IF MOVED, WHEN AND FROM WHERE:

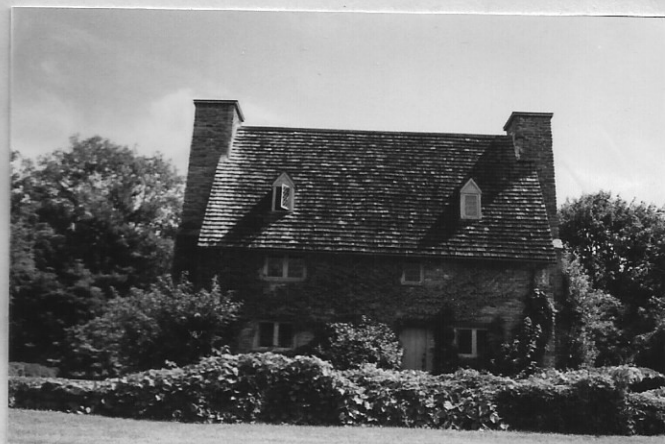
5. ARCHITECT
6. DATE 1639 - (?) BUILDER
STYLE Late Medieval
7. ALTERATIONS Alterations, restorations, and re-restorations have been so extensive that little of the original fabric is now left. 19th century owners lowered the roof pitch, removed one chimney, enlarged the ell, altered fireplaces and partitions. The first restoration, by Norman Isham, took place (continued on next sheet)
8. NOTABLE FEATURES
Masonry construction--said to be the oldest stone house in the English colonies. Immense outside chimneys with sloped weatherings; steep roof, possibly for thatch, possibly for stone. Small casement windows, and one angled window on (continued on next sheet)

the southwest corner--an unusual feature. Sloped exterior walls, 30" at the base, 18" at the top. Outside stair tower.

soon after the house was acquired by the State in 1897. In time the trustees came to feel that this restoration was not adequate and was even perhaps incorrect, and a new restoration was entrusted to J. Frederick Kelly between 1931 and 1937, bringing the house to its present form.
