HISTORIC RESOURCES INVENTORY:
Buildings & Structures

SURVEY OF GUILFORD, NEW HAVEN COUNTY, 06437
June-December 1981

1. ADDRESS 352 Old Whitfield Street
(map 28, lot 32)
2. NAME
(historic) Fredrick Z. Hart
NAME
(common)
3. USE
(historic)
USE
(present) Private house
4. IF MOVED, WHEN AND FROM WHERE:

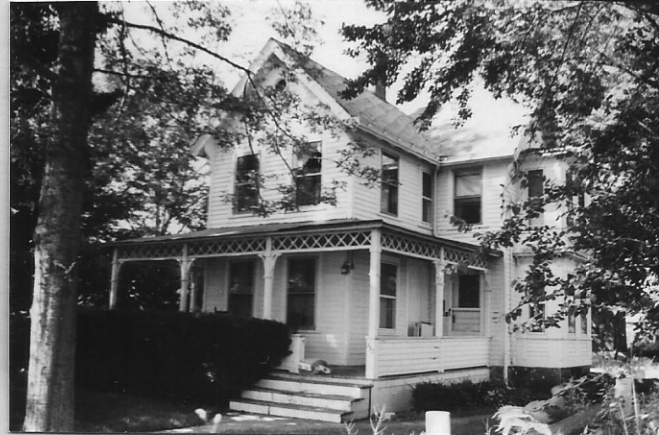
5. ARCHITECT
6. DATE 1892
- BUILDER
STYLE Queen Anne
7. ALTERATIONS
Aluminum windows.
8. NOTABLE FEATURES
Fishscale shingles; two-story bay window; wrap around porch; large stone foundation.

9. ARCHITECTURAL-HISTORICAL
This simple, or vernacular, Queen Anne house has a wrap around porch with square posts, brackets, and spindle work that forms an open frieze. The gable is decorated with a small circular opening and fish scale shingles. The rafter ends are exposed under the eaves and in the gable, where the "brace" modestly decorated barge-board.
