HISTORIC RESOURCES INVENTORY:
Buildings & Structures

SURVEY OF GUILFORD, NEW HAVEN COUNTY, 06437
June-December 1981

1. ADDRESS 455 Old Whitfield Street
(map 29, lot 110)
2. NAME
(historic)
NAME
(common)
3. USE
(historic) Private house
USE
(present) Private house and apartment
4. IF MOVED, WHEN AND FROM WHERE:

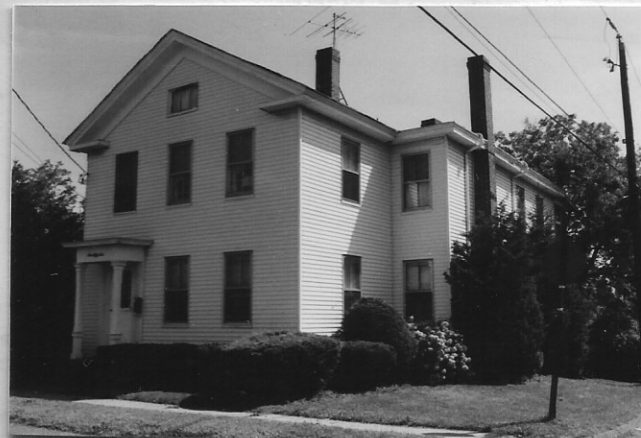
5. ARCHITECT
6. DATE c1870 BUILDER STYLE Probably William Weld
Greek Revival
7. ALTERATIONS
Siding; outside chimney; second floor porch in the rear.

8. NOTABLE FEATURES
Boxed cornice with returns; square gable window; square column porch with a row of dentils along eaves; brick foundation.
9. ARCHITECTURAL-HISTORICAL
Although larger than many of its kin, this Greek Revival house has the three-bay facade typical of Guilford buildings of this style. It is an important member of the large group of Greek Revival style houses outside of the Village of Guilford and helps maintain the residential scale of the street.
This house is thought to be one of the later works of William Weld.

- ☒ Excellent *Front & N. side* ☐ Good ☒ Fair - Clapboard *section S, side* ☐ Poor ☐ Bad
