HISTORIC RESOURCES INVENTORY:
Buildings & Structures

SURVEY OF GUILFORD, NEW HAVEN COUNTY, 06437
June-December 1981

1. **ADDRESS** 11 Park Street
(Map 40, Lot 10)
2. **NAME** Dr. Jared Redfield
(historic)
NAME
(common)
3. **USE**
(historic) Private house
USE
(present) Christ Church Rectory
4. **IF MOVED, WHEN AND FROM WHERE:**

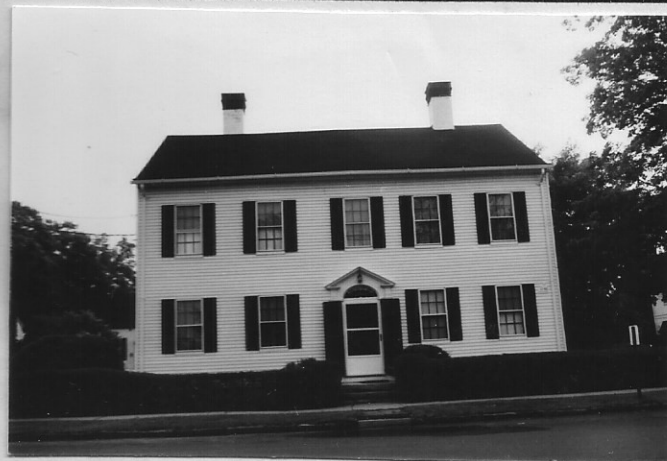
5. **ARCHITECT**
6. **DATE** 1792
- BUILDER** Federal
STYLE
7. **ALTERATIONS**
Siding; rear garage (attached).
8. **NOTABLE FEATURES**
Twin brick chimneys; doorway with a triangular pediment; slender pilasters and a fanlight with decorative lead work; stone slab foundation.

9. **ARCHITECTURAL-HISTORICAL**
The doorway with a fanlight pushing into a triangular pediment is one of the few decorative features of the Dr. Jared Redfield house. The two chimneys indicate a commodious central hall plan inside. A few idiosyncrasies lead one to wonder if parts of the house may have been built at different times; the front door is just slightly off center, and one of the chimneys sits back of the ridgeline. This is a pleasant house, part of an important street.
The house was built in 1792 by Dr. Jared Redfield, a physician who lived here until his death in 1821. Sarah Todd sold the land and house in 1867 to the Rev. Lorenzo T. Bennett - who served Christ Church for about forty years. Christ Church acquired the house from his widow sometime early in the 20th century.
