HISTORIC RESOURCES INVENTORY:
Buildings & Structures

SURVEY OF GUILFORD, NEW HAVEN COUNTY, 06437
June-December 1981

1. ADDRESS 17 Park Street
(map 40, lot 10)
2. NAME Christ Episcopal Church
(historic)
NAME
(common)
3. USE Church
(historic)
USE
(present)
4. IF MOVED, WHEN AND FROM WHERE:

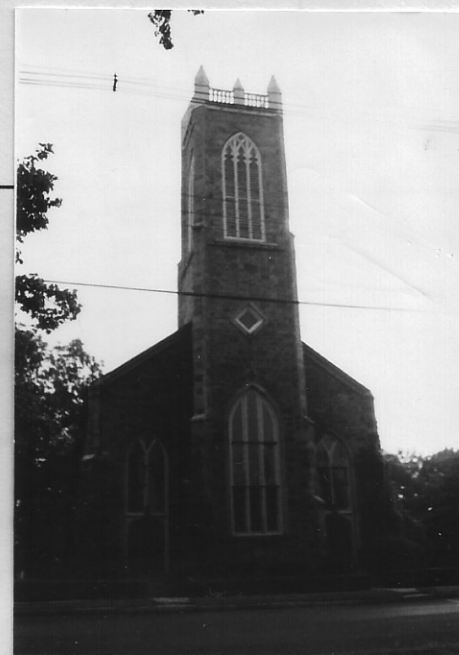
5. ARCHITECT
6. DATE 1838
- BUILDER
STYLE Gothic Revival
7. ALTERATIONS
Addition of parish hall in rear; pinnacles on tower have been replaced. Pinnacles and pierced battlements on the tower have been removed and replaced with modern work; pinnacles were also originally on the buttresses.
8. NOTABLE FEATURES
Uncoursed ashler, Central tower church; wall buttresses; large lancet windows on the tower and the main portion of the church; stained glass windows.

9. ARCHITECTURAL-HISTORICAL The massive stone construction of Christ Episcopal Church shows that it was built as an enduring monument. Corner buttresses on the tower and body add to its solidity. Its central tower is pierced near its base by a lancet window with stained glass, and lancet windows with decorative mullions hold louvers on the sides of the belfry. Lancet openings also make windows along the sides of the church and entrances and windows at either side of the tower. This is important as an early and outstanding example of the Gothic Revival in New England.
