HISTORIC RESOURCES INVENTORY:
Buildings & Structures

SURVEY OF GUILFORD, NEW HAVEN COUNTY, 06437
June-December 1981

1. ADDRESS 1 Park Street
(map 40, lot 11)
2. NAME
(historic) Dr. John Redfield
NAME
(common) Guilford Savings Bank
3. USE
(historic) House
USE
(present) Bank
4. IF MOVED, WHEN AND FROM WHERE:

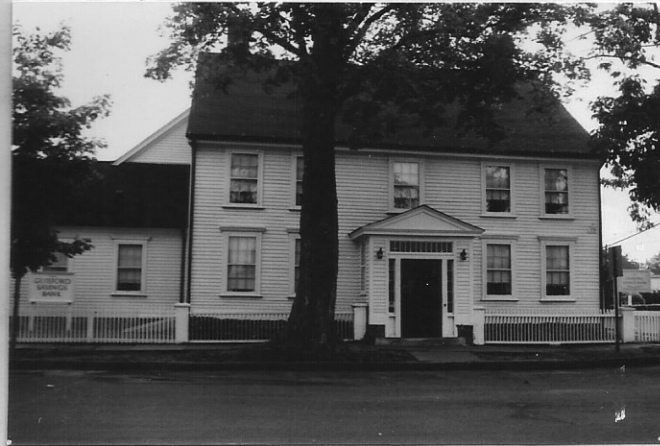
5. ARCHITECT
6. DATE 1780
- BUILDER
STYLE Late Colonial
7. ALTERATIONS
Large additions to the north and rear are modern, as is the enclosed projecting entrance: all added by the Bank. Twin chimneys appear to have been rebuilt, possibly replacing an original single chimney. 6/6 sash.
8. NOTABLE FEATURES
Boxed cornice with molding stepped up over the windows. Pronounced window frames with bold headings accent the facade. Two 12/12 windows in gables. Plank wall construction.
