**HISTORIC RESOURCES INVENTORY:**  
Buildings & Structures

**SURVEY OF GUILFORD, NEW HAVEN COUNTY, 06437**  
June-December 1981

1. **ADDRESS** 31 Park Street  
(map 40, lot 8)
2. **NAME** Guilford Town Hall  
(historic)  
**NAME**  
(common)
3. **USE** Town Hall  
(historic)  
**USE** Town Hall  
(present)
4. **IF MOVED, WHEN AND FROM WHERE:**

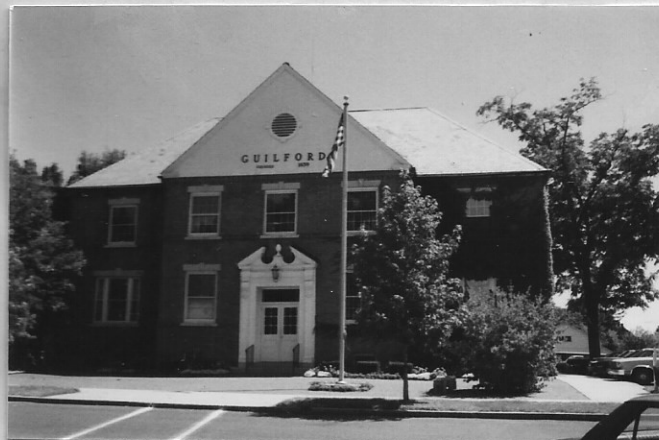
5. **ARCHITECT** George W. Seward
6. **DATE** 1893-4 **BUILDER** Romanesque  
**STYLE** Alteration: Colonial Revival
7. **ALTERATIONS**  
Significant alterations; originally a Romanesque building. In 1947-48 the Town Hall was remodeled from a Romanesque building into a Colonial Revival building by C.F. Townsend, a New Haven architect. In 1973 the roof on the rear portion was raised to provide more office space.
8. **NOTABLE FEATURES**  
Doorway, gable pediment and granite lintles with keystones.

9. **ARCHITECTURAL-HISTORICAL**  
Built in 1893-94 as a Romanesque building, little remains but the basic shape. The fenestration was altered, larger granite capped windows replaced smaller, asymmetrically placed segmented arched windows on the second floor. The Colonial Revival entryway and flanking windows have replaced a large arched opening. Large windows on the first floor replaced large arched windows. The large gable pediment has replaced a smaller gable end and wooden tower. The hipped roof was originally irregularly shaped. The original string course below the second floor windows and corbeling at the cornice line is still visible.
