HISTORIC RESOURCES INVENTORY:
 Buildings & Structures

SURVEY OF GUILFORD, NEW HAVEN COUNTY, 06437
 June-December 1981

1. ADDRESS 49 Park Street
(map 40, lot 4)
2. NAME
(historic) Third Congregational Church
NAME
(common) First Church of Christ
Scientist
3. USE
(historic) Church
USE
(present) Church
4. IF MOVED, WHEN AND FROM WHERE:

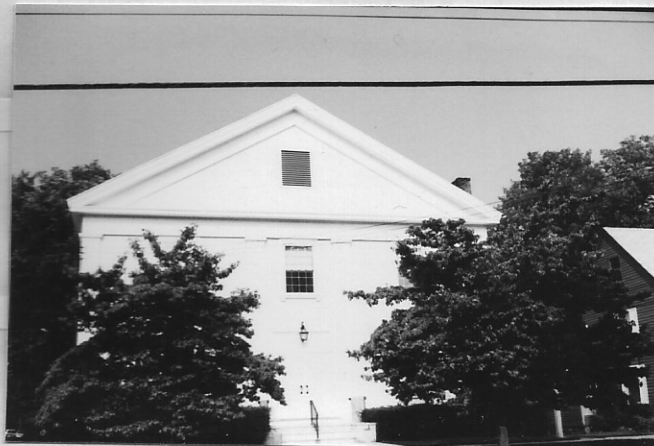
5. ARCHITECT
6. DATE 1844 BUILDER
STYLE Greek Revival
7. ALTERATIONS
Interior remodeled 1862; chapel at rear added 1879; steeple removed 1920.
8. NOTABLE FEATURES
With Doric pilasters, deep entablature, and flushboarded pediment, this is a popular church model of the Greek Revival period. A handsome tower in three stages originally gave it more presence, and shutters articulated the facade. Well kept and sited on the
9. ARCHITECTURAL-HISTORICAL Green's best preserved historic streetscape, it plays a major role.
