**HISTORIC RESOURCES INVENTORY:**  
Buildings & Structures

**SURVEY OF GUILFORD, NEW HAVEN COUNTY, 06437**  
June-December 1981

1. ADDRESS 55 Park Street  
(map 40, lot 3)
2. NAME  
(historic) Jedediah Lathrop  
NAME  
(common)
3. USE  
(historic) Private house  
USE  
(present) Town agencies
4. IF MOVED, WHEN AND FROM WHERE:

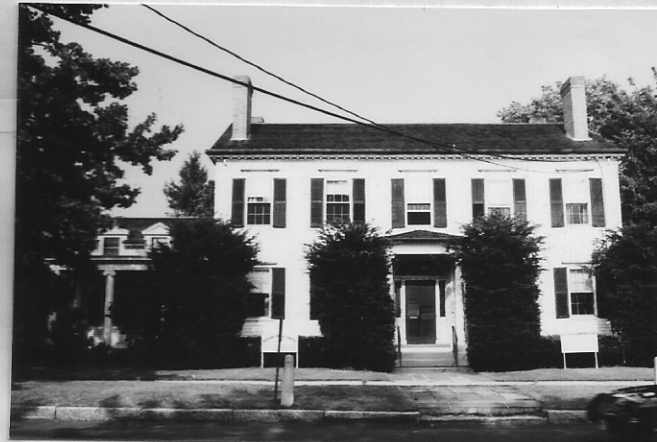
5. ARCHITECT
  6. DATE Various dates are given  
between c1810 and 1822
  7. ALTERATIONS
  8. NOTABLE FEATURES
  9. ARCHITECTURAL-HISTORICAL
- North wing added c1960, details matching house and porch, the Ionic portico imported, surprisingly, from San Francisco. The barn at the rear connected to the house at the same time. Plumbing installed for multiple occupancy.
- A standard Federal house given importance with four chimneys and porch of imposing size. Modillioned cornice and carved window heads and delicate doorway with elliptical fanlight and bold fans in the spandrels contribute to a rich effect.

The dominant feature of the house is the porch, unlike any other in Guilford. A near twin of the notable porch on the Ira Atwater house in New Haven, which is still standing at 222 College Street, its robust scale is noticeably different from the treatment of the door and windows, which are similar to the early Federal work in Guilford that has been associated with Abraham Coan (see Survey Introduction and 29 Broad Street). Ira Atwater was one of the top builders of New Haven at this time; he was also the builder of the Guilford Congregational Church, in 1829. Perhaps Lathrop had Coan build his house for him around 1810, the period when we know Coan was working, and later, in 1829 when he was in Guilford, had Atwater add the porch (and with it, probably, the fans in the spandrels and possibly the modillioned cornice).
