**HISTORIC RESOURCES INVENTORY:**  
 Buildings & Structures

**SURVEY OF GUILFORD, NEW HAVEN COUNTY, 06437**  
 June-December 1981

1. ADDRESS 2 Pearl Street  
(map 40, lot 45)
2. NAME  
(historic) John L. Seward  
NAME  
(common)
3. USE  
(historic) Private house  
USE  
(present) Apartments
4. IF MOVED, WHEN AND FROM WHERE:

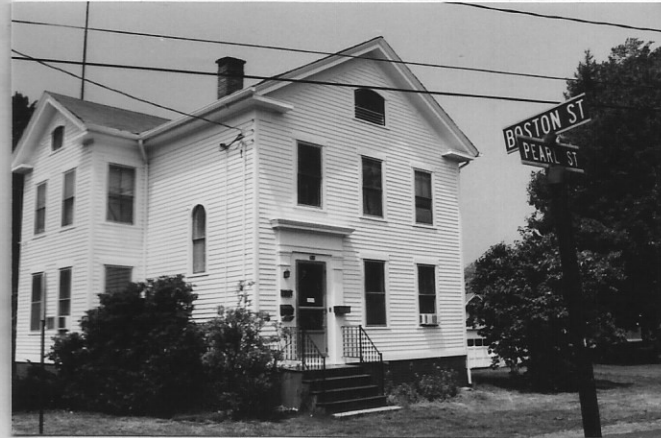
5. ARCHITECT
6. DATE 1876
- BUILDER John C. Norton  
STYLE Greek Revival/  
Italianate
7. ALTERATIONS  
North side addition; stairs to second floor living units;  
front steps and railing.
8. NOTABLE FEATURES  
Wide lintel boards over the 2/2 sash; segmental arch gable windows;  
arched stairway window; doorway with pilasters and entablature; brick  
foundation.
