HISTORIC RESOURCES INVENTORY - BUILDING AND STRUCTURES

Building Name (Common) 37 Pearl Street
 Building Name (Historic) Clarissa K. Pendleton House
 Street Address or Location 37 Pearl Street
 Town/City Guilford Village _____ County New Haven
 Owner(s) Leroy Sperry Revocable Trust Public Private

37 Pearl Street

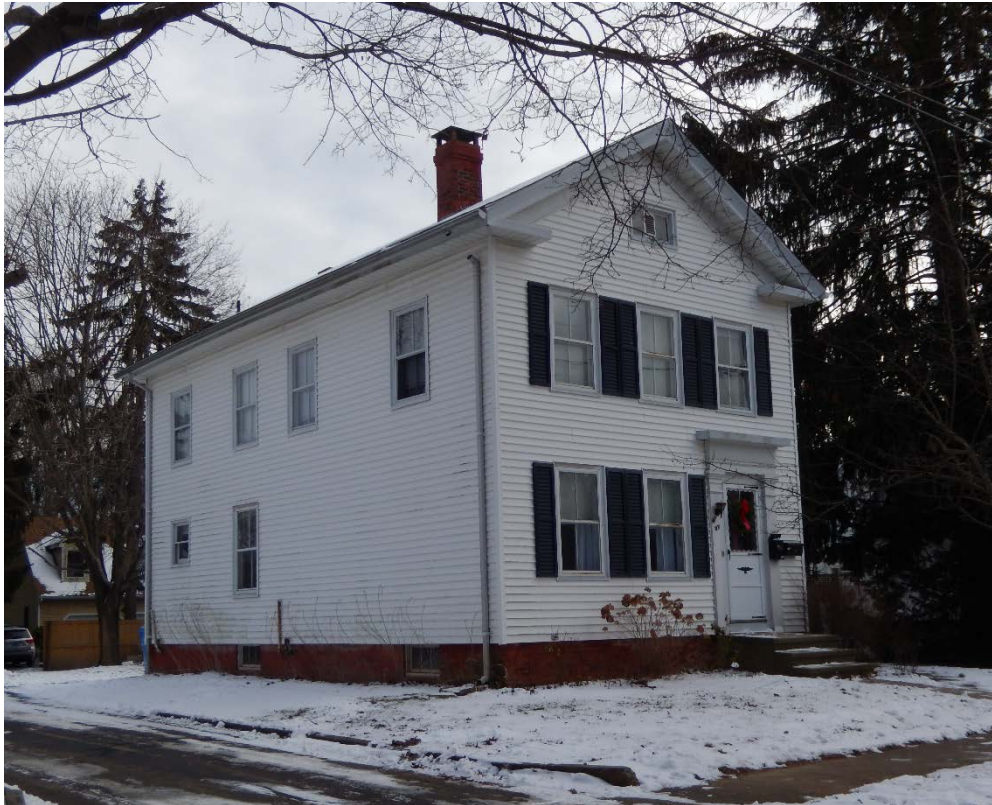
Built c. 1876, this two story Greek Revival house sits atop a brick foundation and is sheathed in white vinyl siding. The front gable roof is covered in asphalt shingles. A casement window with a louvered middle is located at the pediment. Three two over two hung sash windows with black shutters are on the second floor level under cornice returns with two more on the first floor next to a front door entry on the south end of the facade. (See Continuation Sheet)

The door surround has two pilasters on both sides and a full entablature over the top. A concrete stoop leads up to the front entry.
