HISTORIC RESOURCES INVENTORY:
Buildings & Structures

SURVEY OF GUILFORD, NEW HAVEN COUNTY, 06437
June-December 1981

1. ADDRESS 60 Pearl Street
(map 40, lot 52)
2. NAME Elias O. Norton
(historic)
NAME
(common)
3. USE
(historic)
USE
(present) Private house
4. IF MOVED, WHEN AND FROM WHERE:

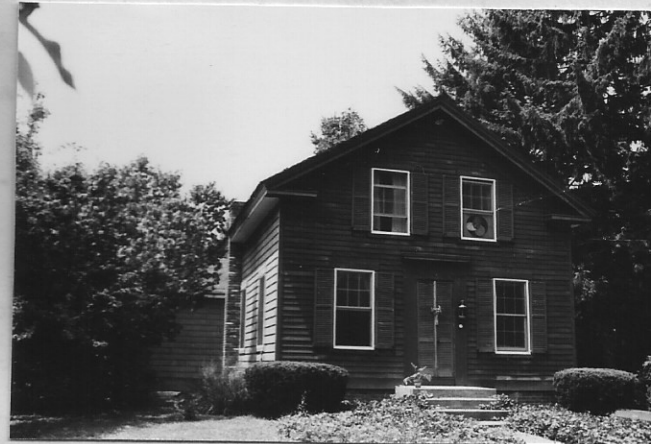
5. ARCHITECT
6. DATE 1879
- BUILDER John C. Norton
STYLE (late) Greek Revival
7. ALTERATIONS
South side wing; outside chimney; shingles on the side.
8. NOTABLE FEATURES
Moulding below the eaves; 6/6 sash; wide lintel boards; plain door frame with a crown moulding above; brick foundation.
9. ARCHITECTURAL-HISTORICAL
John C. Norton built this house for Elias O. Norton, a distant relative, at the end of 1879. John C. Norton, who lived at 42 Pearl Street, built several other houses on this new street at about the same time. Double windows in the gable provide more light than the more common single gable window and are an interesting feature of this house, and may be an alteration. It is a good example of the modest houses of the 1870s.

- ☒ Clapboard *front* ☐ Brick ☐ Stucco ☐ Asbestos Shingle ☐ Other:
☒ Wood Shingle *side* ☐ Fieldstone ☐ Concrete ☐ Asphalt Siding
☐ Board & Batten ☐ Cut Stone ☐ Cobblestone ☐ Aluminum/Vinyl

- a. ☒ Pitched ☒ Gable-front ☐ Hip ☐ Shed ☐ Other:
☐ Saltbox ☐ Cross-gable ☐ Flat Hip ☐ False Dormer
☐ Gambrel ☐ Mansard ☐ Flat ☐ Sawtooth
b. ☐ Tower(s) ☐ Monitor ☐ Cupola ☐ Dormered Gable ☐ Dome
c. ☐ Wood Shingle ☒ Asphalt Shingle ☐ Slate ☐ Metal ☐ Other:

14. NUMBER OF STORIES: *1 1/2* APPROXIMATE DIMENSIONS: LOT SIZE: *approx. 1/2 acre*

- ☐ Excellent ☒ Good ☐ Fair ☐ Poor ☐ Bad
