HISTORIC RESOURCES INVENTORY:
Buildings & Structures

SURVEY OF GUILFORD, NEW HAVEN COUNTY, 06437
June-December 1981

1. ADDRESS 531 Podunk Road
(map 93, lot 7)
2. NAME
(historic) Thomas Dudley
NAME
(common)
3. USE
(historic)
USE
(present) Private house
4. IF MOVED, WHEN AND FROM WHERE:

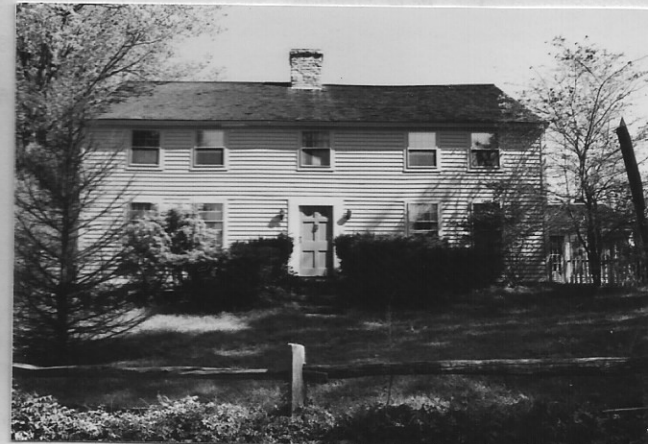
5. ARCHITECT
6. DATE 1733 BUILDER STYLE Colonial
7. ALTERATIONS
Side addition; dormer in the rear roof; chimney (rebuilt in stone).
8. NOTABLE FEATURES
Boxed cornice; 8/8 sash (second floor gable); 6/6 gable sash;
8/12 sash (first floor); wide boards used for the door frame;
stone foundation.
