HISTORIC RESOURCES INVENTORY:
Buildings & Structures

SURVEY OF GUILFORD, NEW HAVEN COUNTY, 06437
June-December 1981

1. ADDRESS 44 Prospect Avenue
(map 2, lot 45)
2. NAME Frank E. Hayden
(historic)
NAME
(common)
3. USE
(historic)
USE Private house
(present)
4. IF MOVED, WHEN AND FROM WHERE:

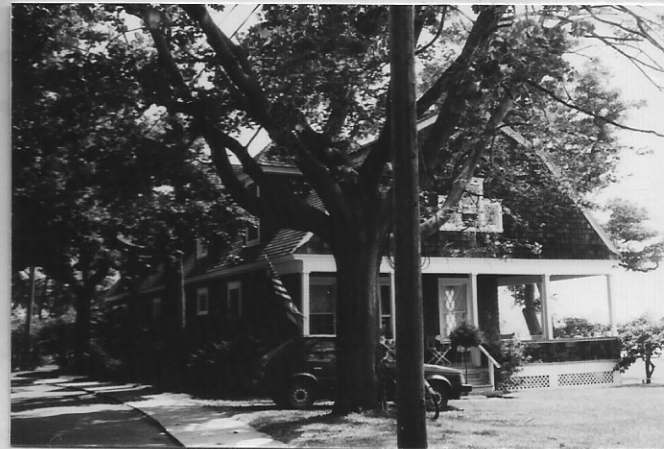
5. ARCHITECT
6. DATE 1909
7. ALTERATIONS
8. NOTABLE FEATURES
Alternating hip and gable roof dormers; decorative diamond pane window overhanging second story from the roof of the porch (supported by square posts).

9. ARCHITECTURAL-HISTORICAL
The overhanging gambrel-roofed second story makes a pleasant open porch for this seaside house as well as offering cool shade for the rooms behind it. Dormers with different roof styles add a playful note to the broad roof of this house. It is a good representative of the cottages built along the Sound in the early years of this century. Frank E. Hayden tore down two earlier cottages on this site and had this single large cottage built on the site.
