HISTORIC RESOURCES INVENTORY - BUILDING AND STRUCTURES

Building Name (Common) 4 Quonnipaug Hill Road
 Building Name (Historic) 4 Quonnipaug Hill Road
 Street Address or Location 4 Quonnipaug Hill Road
 Town/City Guilford Village _____ County New Haven
 Owner(s) Dianne Macintosh & Randal Crosby Public Private

Style of building Colonial Revival Date of Construction c. 1940

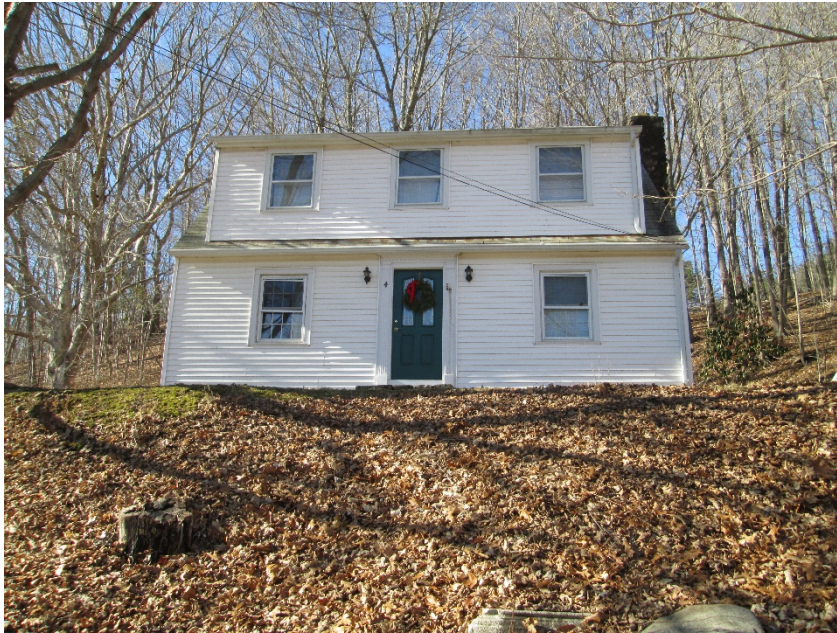
Built c. 1940, this two story Colonial Revival style house sits atop a concrete cinder block foundation and is sheathed in white vinyl siding. The side gable roof is covered in asphalt shingles with a chimney on the north eaveside. A full facade shed dormer with three eight over eight hung sash windows. Two more of the same windows are on either side of the first floor level with a door entry in the middle. (See Continuation Sheet)

View East, camera facing west Negative on File _____

The green door has two vertical panels on the bottom and two vertical window panes on the top. The white door surround has two pilasters and a small entablature crown. A stone step leads up to the front door.
