HISTORIC RESOURCES INVENTORY - BUILDING AND STRUCTURES

Building Name (Common) 186 River Street
 Building Name (Historic) Salmon Shelley House
 Street Address or Location 186 River Street
 Town/City Guilford Village _____ County New Haven
 Owner(s) Wendy Davis Public Private

CONTINUATION SHEET

186 River Street

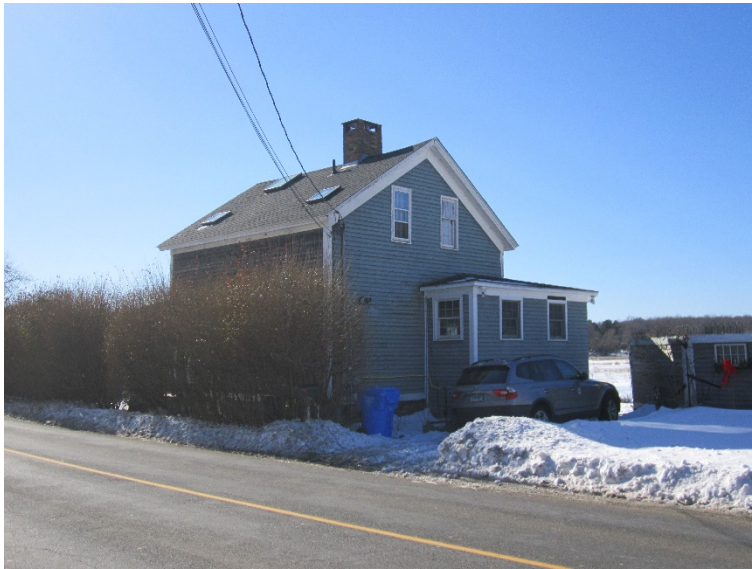
Built c. 1800, this one and a half story Vernacular style building sits atop a stone foundation and is sheathed in natural wood clapboard siding, painted blue on the north side elevation. The side gable roof is covered in architectural shingles with a chimney in the ridgeline and three skylights. Only a door on the south end of the facade is visible between the bushes lining the east side of the house. (See Continuation Sheet)

The white four panel door has a decorative surround with pilasters and a pedimented crown. Inside the pediment is a round fanlight design. The door is deteriorated and has no stoop leading up to it, but it used to be the front entry. Two wings are visible on the north and south ends that seem to connect around the west side of the house, according to aerial maps.
