HISTORIC RESOURCES INVENTORY: Buildings & Structures

SURVEY OF GUILFORD, NEW HAVEN COUNTY, 06437 June-December 1981

28 South Fair Street (map 32, lot 53)

Adolph G. Sommer

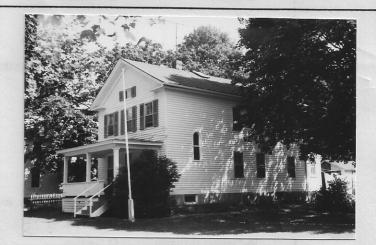
Wide lintel boards; slightly arched gable window; round arched stairway window; large square post porch with a plain railing.

The arched stairwell window and curved gable window point to later influences on a typical Greek Revival house. This house is similar to another around the corner on High Street and several others at the north end of the first block of Church Street. Possibly all are the work of the same builder whose identity is not presently known.
