HISTORIC RESOURCES INVENTORY:
Buildings & Structures

SURVEY OF GUILFORD, NEW HAVEN COUNTY, 06437
June-December 1981

1. ADDRESS 49 South Fair Street
(map 32, lot 63)
2. NAME
(historic) McManus
NAME
(common)
3. USE
(historic)
USE
(present) Private house
4. IF MOVED, WHEN AND FROM WHERE:

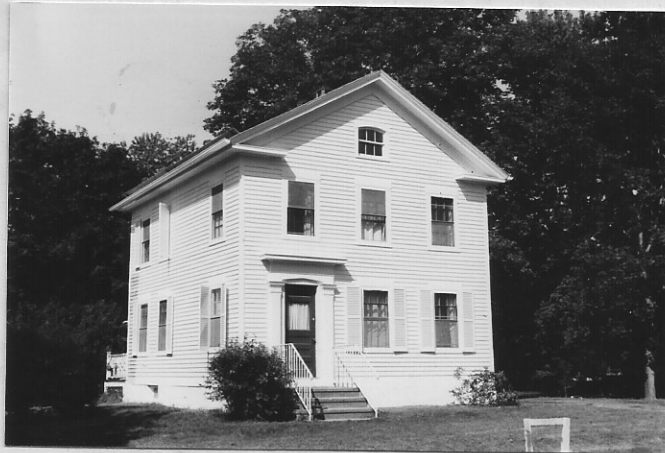
5. ARCHITECT
6. DATE 1873
- BUILDER
STYLE Greek Revival/Italianate
7. ALTERATIONS
Railing on the front steps.

8. NOTABLE FEATURES
Boxed cornice with returns; segmental arch window in the gable; doorway with pilasters and an entablature (with large dentils under the cornice and an ogee curve in the frieze).

Similar doorways, with a broken arch in the entablature, adorn several houses in Guilford. Its form may have been the specialty of a certain builder or lumber dealer. The crisp outlines of this house are noteworthy.
