HISTORIC RESOURCES INVENTORY:
Buildings & Structures

SURVEY OF GUILFORD, NEW HAVEN COUNTY, 06437
June-December 1981

1. ADDRESS 107 State Street
(map 47, lot 25)
2. NAME
(historic) Samuel Scranton, Jr.
NAME
(common)
3. USE
(historic) Private house
USE
(present) Offices and apartment
4. IF MOVED, WHEN AND FROM WHERE:

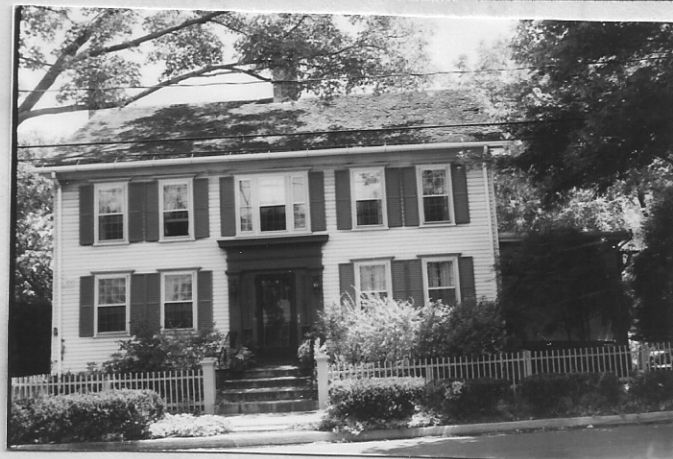
5. ARCHITECT
6. DATE 1787
- BUILDER
STYLE Federal
7. ALTERATIONS
Aluminum/vinyl siding; external chimney and side additions; central chimney rebuilt; railing on front steps.

8. NOTABLE FEATURES
Triple window and a monumental door, enhanced by an unusually high and broad flight of front steps.

9. ARCHITECTURAL-HISTORICAL
The house of Samuel Scranton Jr. has a balanced facade with fine details; crown moldings making small entablatures for the windows-- a motif repeated in the broad Greek Revival entablature over the door. The width of the three-part window carries the strong center of symmetry up to the second floor. A handsome fence with squared posts, opening to broad front steps, demonstrates the importance of fencing in the overall appearance of a building in its setting. This is a good example of the town's Federal architecture, embellished, as was so often the case, by a later door.
