HISTORIC RESOURCES INVENTORY:
Buildings & Structures

SURVEY OF GUILFORD, NEW HAVEN COUNTY, 06437
June-December 1981

1. ADDRESS 138 State Street
(map 46, lot 126)
2. NAME
(historic) Henry Kingsnorth (also called
NAME Comfort Starr house)
(common)
3. USE
(historic)
USE
(present) Private house
4. IF MOVED, WHEN AND FROM WHERE:

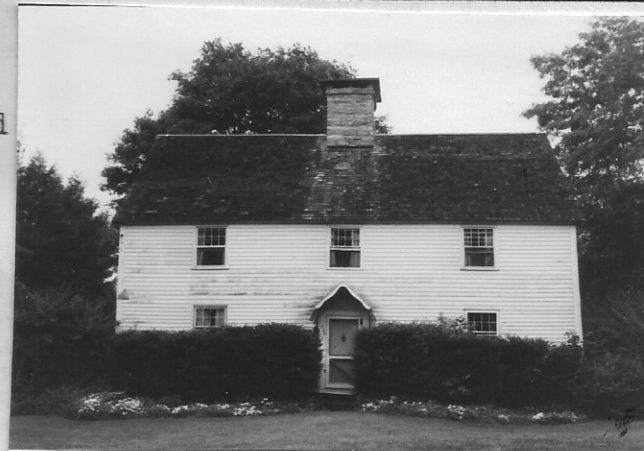
5. ARCHITECT
6. DATE See below BUILDER
STYLE Colonial
7. ALTERATIONS
Door hood modern. An illustration in Kelly, Early Domestic Architecture, Pl. II, shows the house before the addition.
8. NOTABLE FEATURES Under the clapboards is a half-timber frame with clay, daub, and wattle in-fill. Inside the added leanto are old clapboards on the former outside wall. Third story overhang of pronounced projection. Small windows with 8/12 and 8/8 sash. The present owner (continued on next sheet)
