HISTORIC RESOURCES INVENTORY:
 Buildings & Structures

SURVEY OF GUILFORD, NEW HAVEN COUNTY, 06437
 June-December 1981

1. ADDRESS 205 State Street
(map 46, lot 119)
2. NAME John Collins II
(historic)
NAME
(common)
3. USE
(historic)
USE Private house
(present)
4. IF MOVED, WHEN AND FROM WHERE:

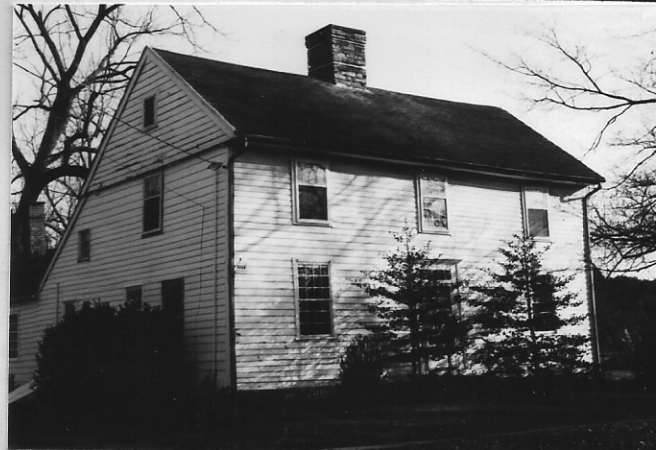
Additions to the rear; railing on front steps; aluminum storm windows added.

Ceiling heights: ground floor 9'0" except lean-to - 7' ; second floor 6'-8" approximately.

The John Collins II house is one of Guilford's earliest surviving houses. It is early Colonial style with a five-window facade, corbels under the roof, and a lean-to which is probably not part of the original construction. The roof's wide overhang at the front presumably kept rain off the door. The paneled door and doorway attracted the notice of architectural historian J. Frederick Kelly, who labelled it "dignified and well proportioned." The house is a valuable part of the town's architectural heritage.
