HISTORIC RESOURCES INVENTORY:
Buildings & Structures

SURVEY OF GUILFORD, NEW HAVEN COUNTY, 06437
June-December 1981

1. ADDRESS 223 State Street
(map 46, lot 116)
2. NAME
(historic) Samuel Hall
NAME
(common) Starr House
3. USE
(historic)
USE
(present) Private house
4. IF MOVED, WHEN AND FROM WHERE:

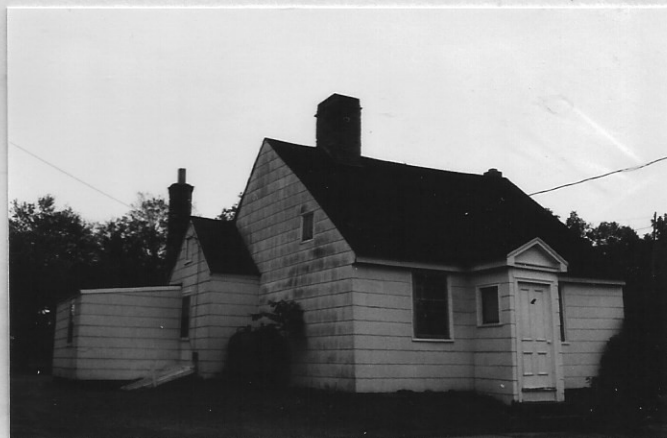
Negative Roll 13: 2

5. ARCHITECT
6. DATE 1669 and 1716
- BUILDER
STYLE Colonial
7. ALTERATIONS
Walls shingled; stone foundation partly covered; asphalt roofing; doorway and wings added; 2/2 sash in one or more windows. Beyond such details, the house has probably been so changed in the course of three centuries that little more than frame and chimney now remain
8. NOTABLE FEATURES of the original fabric.
The survival of so rudimentary a house from the period of Guilford's settlement is extraordinary. This house is a vital link to that most distant past.
