**HISTORIC RESOURCES INVENTORY:**  
 Buildings & Structures

**SURVEY OF GUILFORD, NEW HAVEN COUNTY, 06437**  
 June-December 1981

1. ADDRESS 276 State Street  
(map 54, lot 10)
2. NAME  
(historic) Griswold-Davis  
NAME  
(common)
3. USE  
(historic)  
USE  
(present) Private house
4. IF MOVED, WHEN AND FROM WHERE:

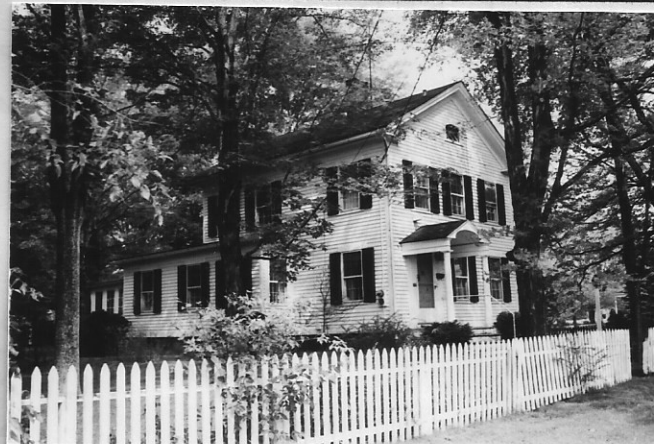
5. ARCHITECT
6. DATE 1876
- BUILDER  
STYLE Greek Revival
7. ALTERATIONS  
Rear addition; railing of front steps. The entry porch may perhaps be an addition of the Colonial Revival of the 1920s or '30s.
8. NOTABLE FEATURES

9. ARCHITECTURAL-HISTORICAL  
 Conservative builders of Guilford carried the Greek Revival form into the last quarter of the 19th century. Details like the door placement and the cornice with returns belong squarely to the Greek Revival era. The segmental arch in the gable window shows the influence of the later Italianate style. A long stretch of distinguished picket fence and mature trees sets off the Griswold-Davis house.
