HISTORIC RESOURCES INVENTORY:
 Buildings & Structures

SURVEY OF GUILFORD, NEW HAVEN COUNTY, 06437
 June-December 1981

1. ADDRESS 292 State Street
(map 54, lot 11)
2. NAME
(historic) Capt. Samuel Lee
NAME
(common)
3. USE
(historic)
USE Private house
(present)
4. IF MOVED, WHEN AND FROM WHERE:

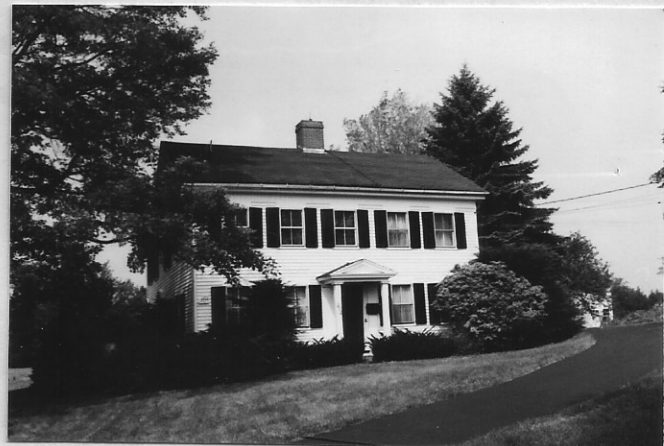
5. ARCHITECT
6. DATE 1794
- BUILDER
STYLE Federal
7. ALTERATIONS
The entry porch is a later addition. Chimney appears to have been rebuilt. 2/2 sash; screened porch at rear.

9. ARCHITECTURAL-HISTORICAL
The even spacing of the five windows along the second story of Capt. Samuel Lee's second house is unusual. Normally in this period, the center section, which contains the doorway, gets greater emphasis and more space. An entry portico added later now strengthens the central focus of the facade. A more delicate Federal pediment embellishes a side entrance. This house is set in a wonderful sweep of lawn, near which is a splendid 19th century barn topped by a handsome square cupola.
