HISTORIC RESOURCES INVENTORY - BUILDING AND STRUCTURES

Building Name (Common) 32 State Street
 Building Name (Historic) Calvin McKnight House
 Street Address or Location 32 State Street
 Town/City Guilford Village _____ County New Haven
 Owner(s) Cornelia and Joerg Bewersdorf Public Private

32 State Street

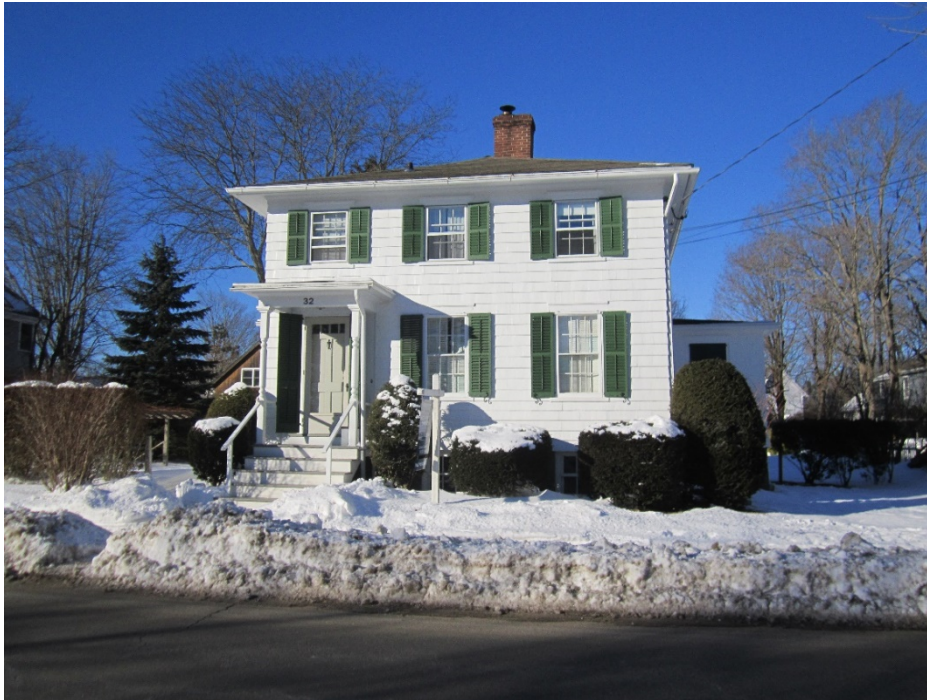
Built in 1850, this Italianate style building sits atop a stone brick foundation and is sheathed in white wood shingles. The hip roof and back gable is covered in architectural shingles and has one chimney at the front peak. Three six over six hung sash windows with green shutters are located on the second floor level. Two of the same windows are on the first floor level with a front door entry at the south side of the front facade. (See Continuation Sheet)

The door has four panels with a four pane transom window at the top. It sits under a covered entry that has a hip roof with a wide overhang and decorative white support posts. The front door entry also has green shutters and sits at the top of a wooden stoop.
