HISTORIC RESOURCES INVENTORY:
Buildings & Structures

SURVEY OF GUILFORD, NEW HAVEN COUNTY, 06437
June-December 1981

1. ADDRESS 48 State Street
(map 39, lot 55)
2. NAME
(historic) Nathaniel Hall
NAME
(common)
3. USE
(historic)
USE
(present) Office and apartment
4. IF MOVED, WHEN AND FROM WHERE:

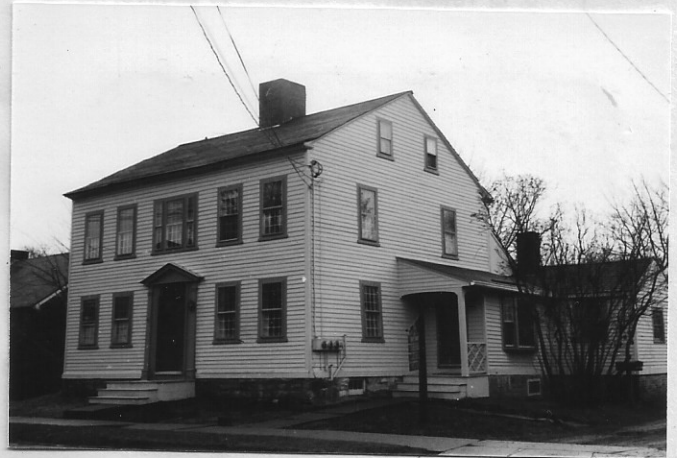
5. ARCHITECT 1770
6. DATE 1770
- BUILDER STYLE Colonial
7. ALTERATIONS
Additions to the rear and north side.

8. NOTABLE FEATURES
Pedimented doorway; 12/12 sash.

9. ARCHITECTURAL-HISTORICAL
Said to have been built in 1770, this house seems to have been brought up to date around 1810 by a changed roofline and the addition of several Federal Period details. A three-part window on the second floor echoes the Palladian taste, and the triangular pediment and pilasters around the doorway also point to the period. The house plays a conspicuous supporting role in its neighborhood.

The second floor was raised about 1810 when a Federal pedimented porch was added to the front entry. The porch, shutters and other later detail work were removed in 1979.
