**HISTORIC RESOURCES INVENTORY:**  
 Buildings & Structures

**SURVEY OF GUILFORD, NEW HAVEN COUNTY, 06437**  
 June-December 1981

1. ADDRESS 521 State Street  
(map 80, lot 107)
2. NAME  
(historic) Russell Benton  
NAME  
(common)
3. USE  
(historic)  
USE  
(present) Private house
4. IF MOVED, WHEN AND FROM WHERE:

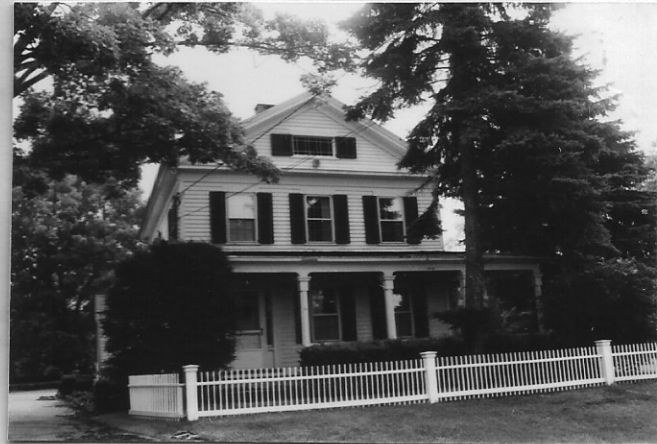
5. ARCHITECT
6. DATE c1854
- BUILDER STYLE Greek Revival
7. ALTERATIONS  
The porch with its square columns and stylized capitals may possibly have been added later, but not very much later, for this type of work is familiar in New Haven by the 50s.
8. NOTABLE FEATURES

A wide porch and projecting cornices in high relief, casting strong shadow lines on the white walls, give this house pronounced character. The handsome fence (its square posts echoing the square columns of the porch) further strengthens the clarity of the architectural composition in its surrounding landscape. Well maintained, this is pleasing and a fine example of Guilford's rural architecture of the mid-19th century.

Notable Features:    Cornices, porch, fence, surrounding grounds.
