HISTORIC RESOURCES INVENTORY:
 Buildings & Structures

SURVEY OF GUILFORD, NEW HAVEN COUNTY, 06437
 June-December 1981

1. ADDRESS 72 State Street
(map 46, lot 1)
2. NAME
(historic) Nathan Bradley (also called
NAME Abel Chittenden house)
(common)
3. USE
(historic)
USE Private house
(present)
4. IF MOVED, WHEN AND FROM WHERE:

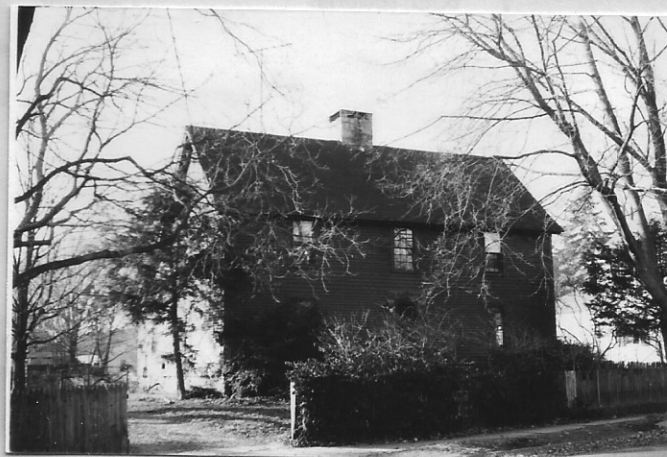
5. ARCHITECT
6. DATE 1665
- BUILDER Colonial
- STYLE
7. ALTERATIONS The house was considerably altered in the 19th century: paneling, doors, sash, some flooring, and chimney removed, and the roof in all probability rebuilt. It has since been restored as accurately as possible, but today it is hard to be sure how much of the 17th century remains.

8. NOTABLE FEATURES Graduated clapboards are an interesting feature of this 17th century "saltbox." A separate foundation indicates that the house was originally built without its leanto at the rear. The roof has been extended to overhang at front and sides, probably in the 19th century, but its slope is likely to be that of its original construction.

9. ARCHITECTURAL-HISTORICAL Plain window and door frames are early features. Insofar as it still actually retains 17th century materials, it is one of Guilford's oldest houses on an important street. Nathan Bradley, age 20, and his brother, Stephen, 16, settled in Guilford about 1658. It is said they came from Bingley, West Riding Yorkshire. Nathan discovered the source of the Hammonasett River - he died in November 1713. The house was sold 28 May 1667 to John Chittenden, son of William and one of the original settlers. He deeded it to his son Abel in 1712.
